## COMMUNITY FORESTRY COMMISSION

**RE: Visual Tree Assessment inspection of two maple street trees 514 Willamina Avenue Forest Grove, OR 97116.**

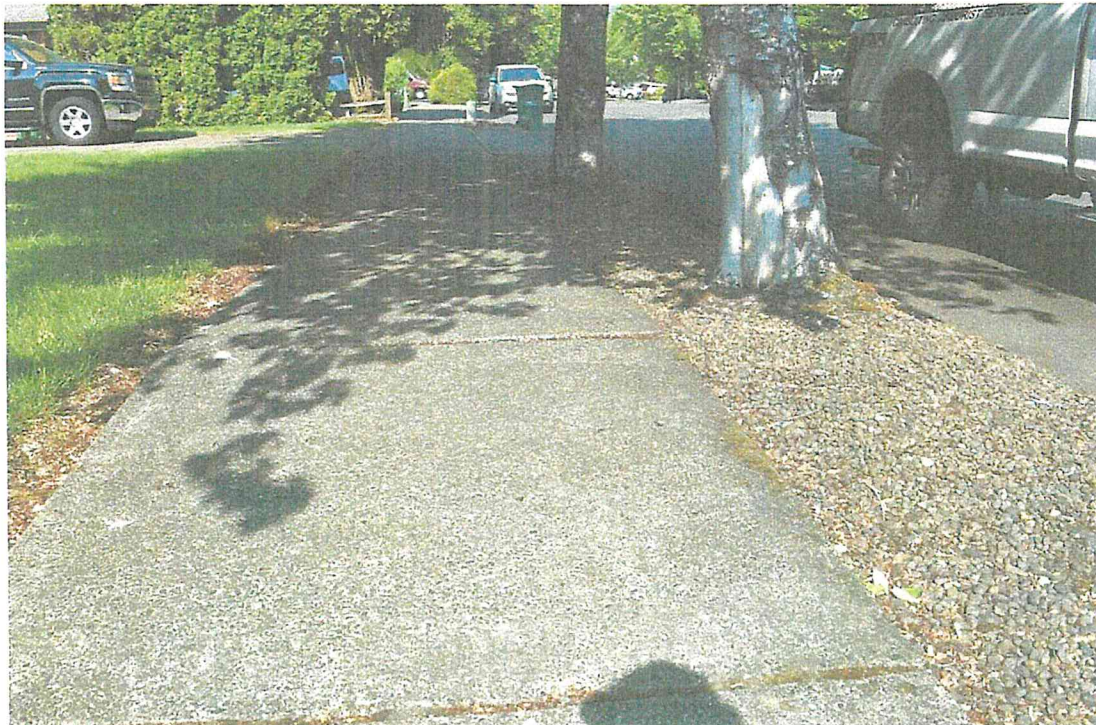
The maple trees are in the sidewalk planter strip in front of the house on the south side of the street. The eastern tree is 12" DBH and has been damaged by vehicles over the years. The tree has girdled roots and the roots are lifting the concrete. Hammer testing the damaged area on the east side sounded hollow. Also has roots heading toward the water meters. Tree has poor branch attachments.

View of east tree with old vehicle impact scar and the lifted concrete is visible closer to the tree.

I recommend the maple trees be removed since the trees are in poor condition and are causing infrastructure damages. Replanting of two trees should be done late fall when the rain weather starts. The trees replacements need to have roots that stay smaller in the limited planting space and follow the City of Forest Grove recommended street tree list.

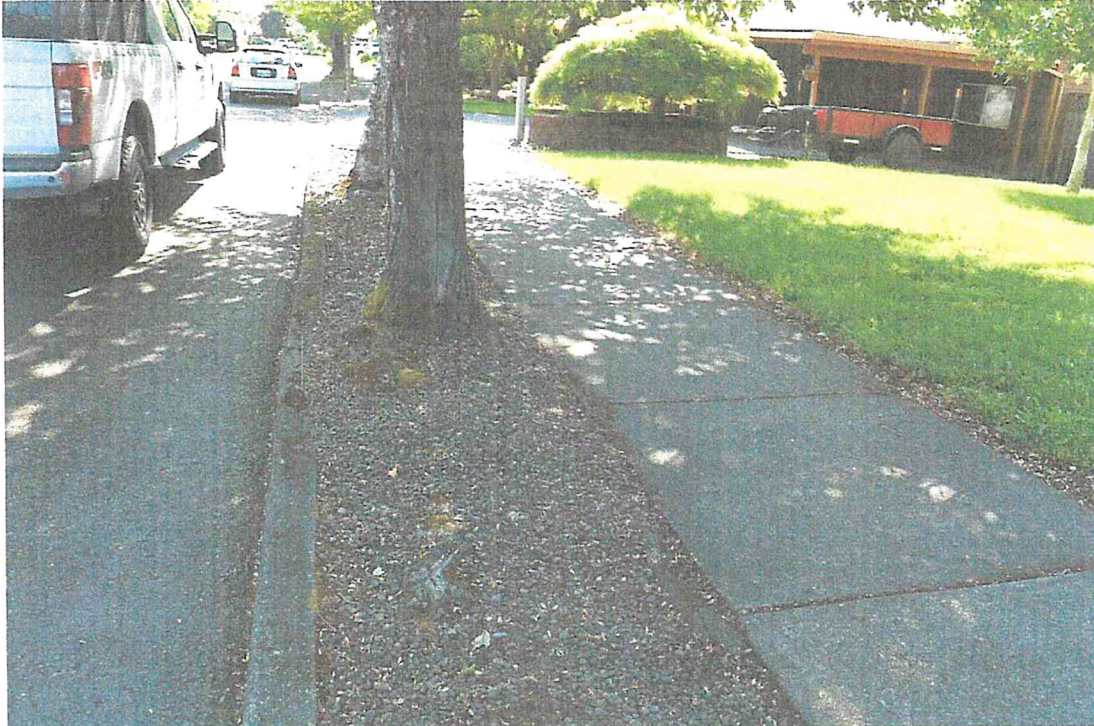
The western tree is 16" DBH and has vehicle damages. The roots are also lifting the concrete. The branching attachments are poor with much defect seen. Clay soils the roots of both trees are at the surface and have made the concrete tripping hazards. Both trees are diseased in my 45+ years of field work.

View of how narrow the planter strip is and the west tree and the above ground surface roots. The last concrete pads on bottom are where the roots are lifting the concrete on the lawn side of the pads. Tree scar is also visible on the west side.
