## COMMUNITY FORESTRY COMMISSION

**RE: Visual Tree Assessment inspection of two maple street trees 514 Willamina Avenue Forest Grove, OR 97116.**

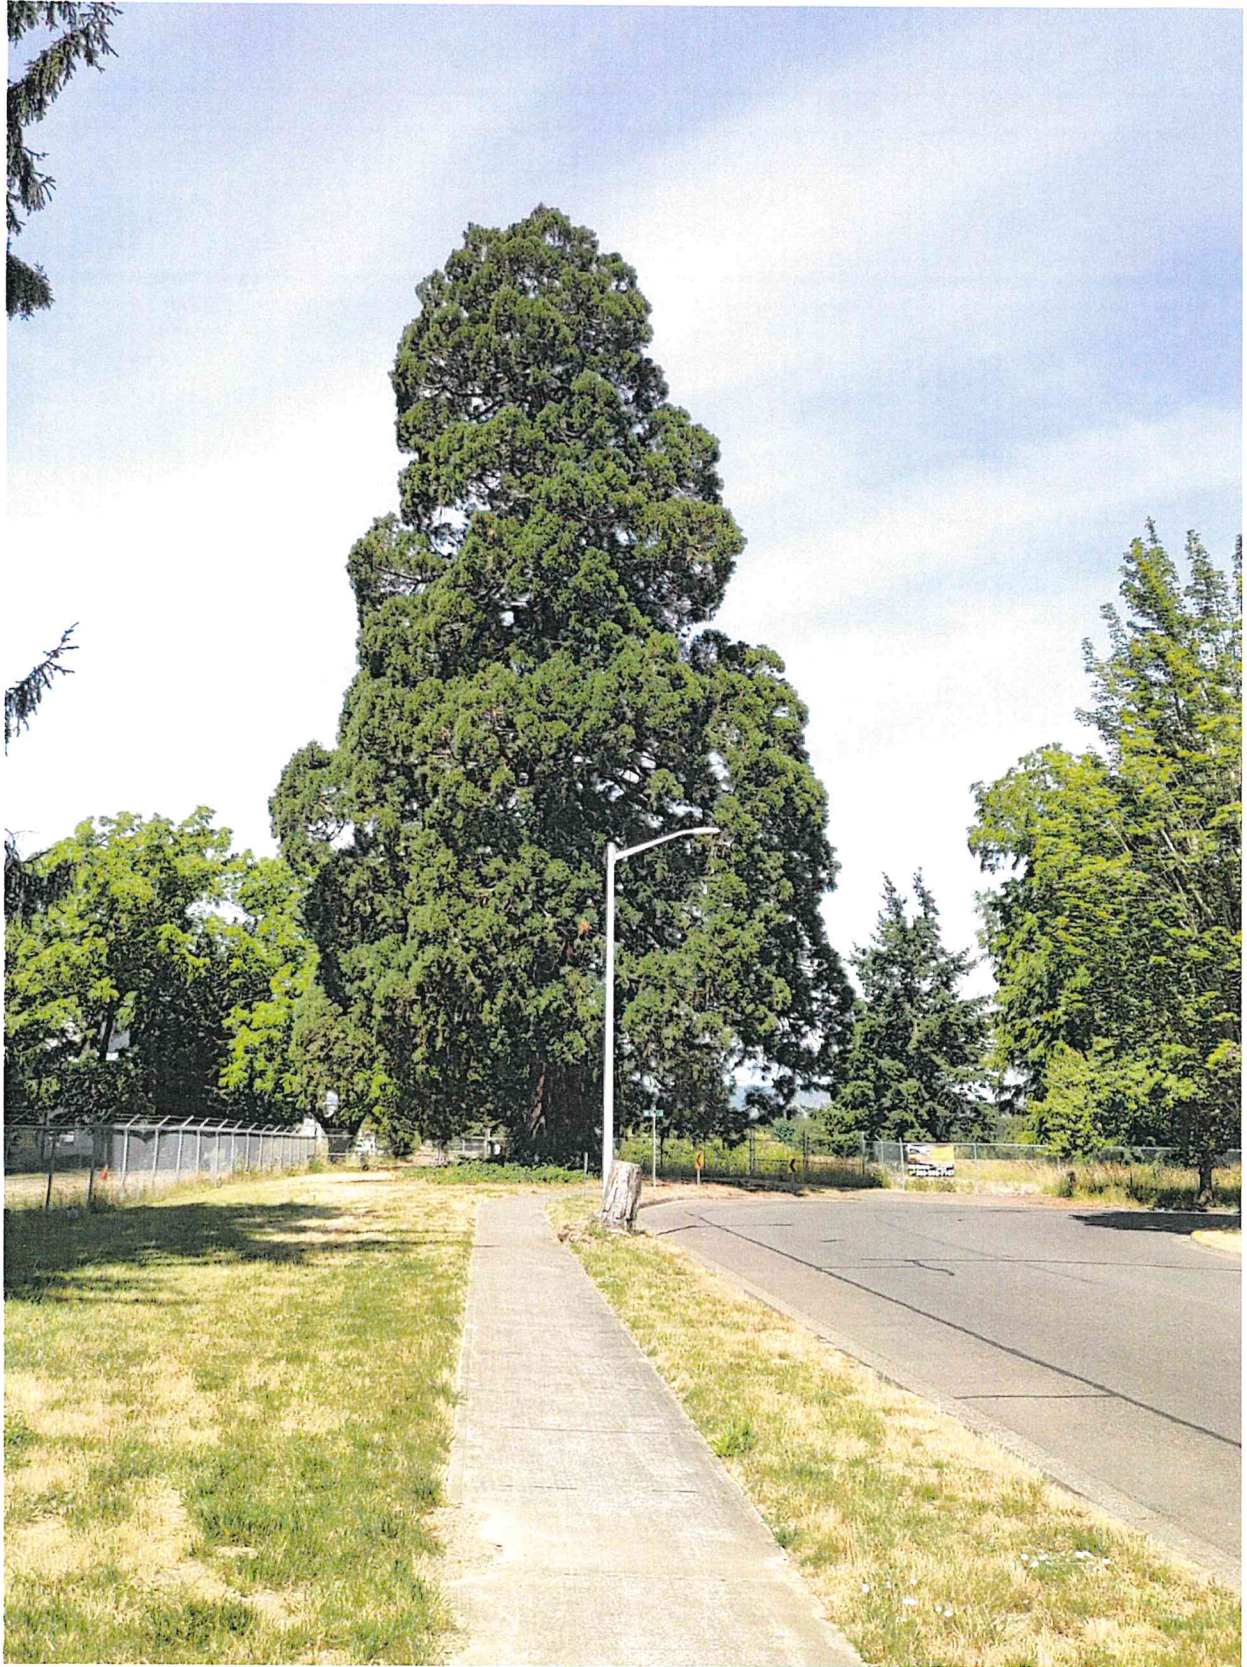
## Mountain View and Heather Street

The maple trees are in the sidewalk planter strip in front of the house on the south side of the street. The eastern tree is 12" DBH and has been damaged by vehicles over the years. The tree has girdled roots and the roots are lifting the concrete. Hammer testing the damaged area on the east side sounded hollow. Also has roots heading toward the water meters. Tree has poor branch attachments.

The western tree is 16" DBH and has vehicle damages. The roots are also lifting the concrete. The branching attachments are poor with much defect seen. Clay soils the roots of both trees are at the surface and have made the concrete tripping hazards. Both trees are diseased in my 45+ years of field work.

I recommend the maple trees be removed since the trees are in poor condition and are causing infrastructure damages. Replanting of two trees should be done late fall when the rain weather starts. The trees replacements need to have roots that stay smaller in the limited planting space and follow the City of Forest Grove recommended street tree list.
