**To:** Historic Landmarks Board

**Re:** May 25 Agenda

**Date:** May 18, 2021

## The Repair of Historic Wooden Windows

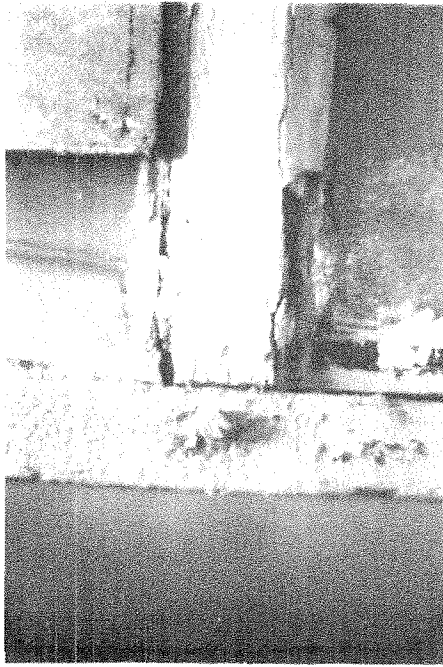
Figure 4a. The following series of photographs of the repair of a historic double-hung window use a unit which is structurally sound but has many layers of paint, some cracked and missing putty, slight separation at the joints, broken sash cords, and one cracked pane. Photo: John H. Myers

The routine maintenance required to upgrade a window to "like new" condition normally includes the following steps: 1) some degree of interior and exterior paint removal, 2) removal and repair of sash (including reglazing where necessary), 3) repairs to the frame, 4) weatherstripping and reinstallation of the sash, and 5) repainting. These operations are illustrated for a typical double-hung wooden window (see figures 4a-f), but they may be adapted to other window types and styles as applicable.

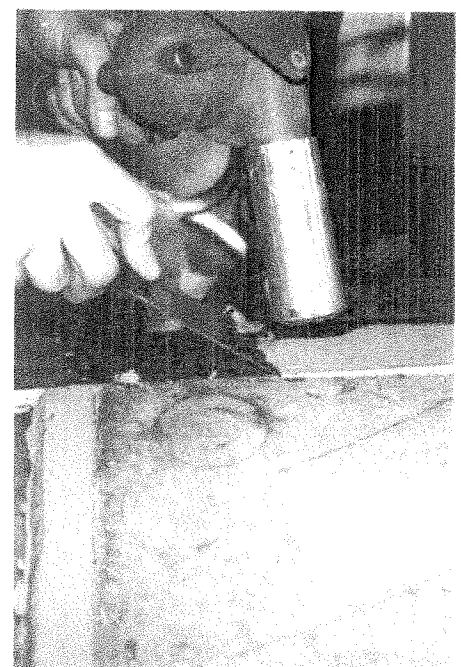
Figure 4c. Sash can be removed and repaired in a convenient work area. Paint is being removed from this sash with a hot air gun while an asbestos sheet protects the glass from sudden temperature change. Photo: John H. Myers

The sash can be stripped of paint using appropriate techniques, but if any heat treatment is used (see figure 4c), the glass should be removed or protected from the sudden temperature change which can cause breakage. An

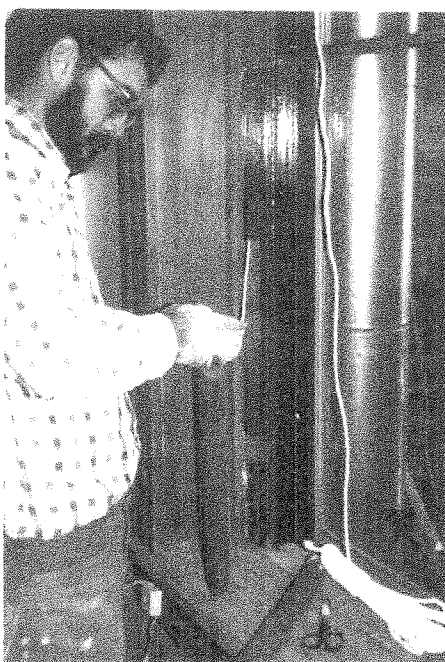
Figure 4e. A common repair is the replacement of broken sash cords with new cords (shown) or with chains. The weight pocket is often accessible through a removable plate in the jamb, or by removing the interior trim. Photo: John H. Myers

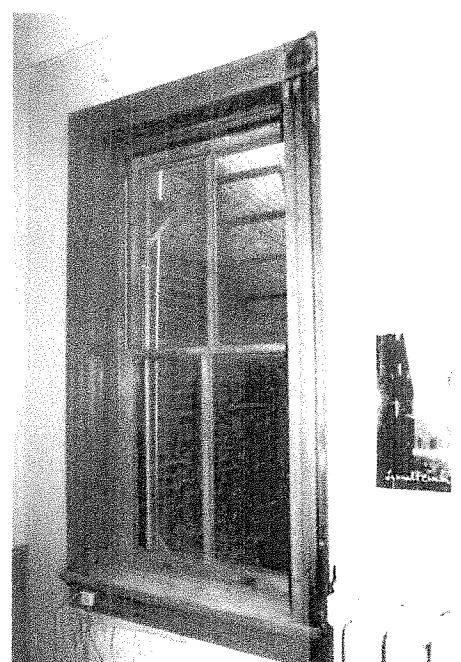
Figure 4f. Following the relatively simple repairs, the window is weathertight, like new in appearance, and serviceable for many years to come. Both the historic material and the detailing and craftsmanship of this original window have been preserved. Photo: John H. Myers

The operations just discussed summarize the efforts necessary to restore a window with minor deterioration to "like new" condition (see figure 4f). The techniques can be applied by an unskilled person with minimal training and experience. To demonstrate the practicality of this approach, and photograph it, a Technical Preservation Services staff member repaired a wooden double-hung, two over two window which had been in service over ninety years. The wood was structurally sound but the window had one broken pane, many layers of paint, broken sash cords and inadequate, worn-out weatherstripping. The staff member found that the frame could be stripped of paint and the sash removed quite easily. Paint, putty and glass removal required about one hour for each sash, and the reglazing of both sash was accomplished in about one hour. Weatherstripping of the sash and frame, replacement of the sash cords and reinstallation of the sash, parting bead, and stop required an hour and a half. These times refer only to individual operations; the entire proc-
